INVESTIGATION NO. 2961
SOUTHERN RAILWAY COMPANY
REPORT IN RE ACCIDENT
NEAR WHITE SULPHUR, GA., ON
DECEMBER 19, 1945

Accident near White Sulphur, Ga., on December 19, 1945,
caused by failure to operate the following train
in accordance with the rules governing movement
when signals are imperfectly displayed.

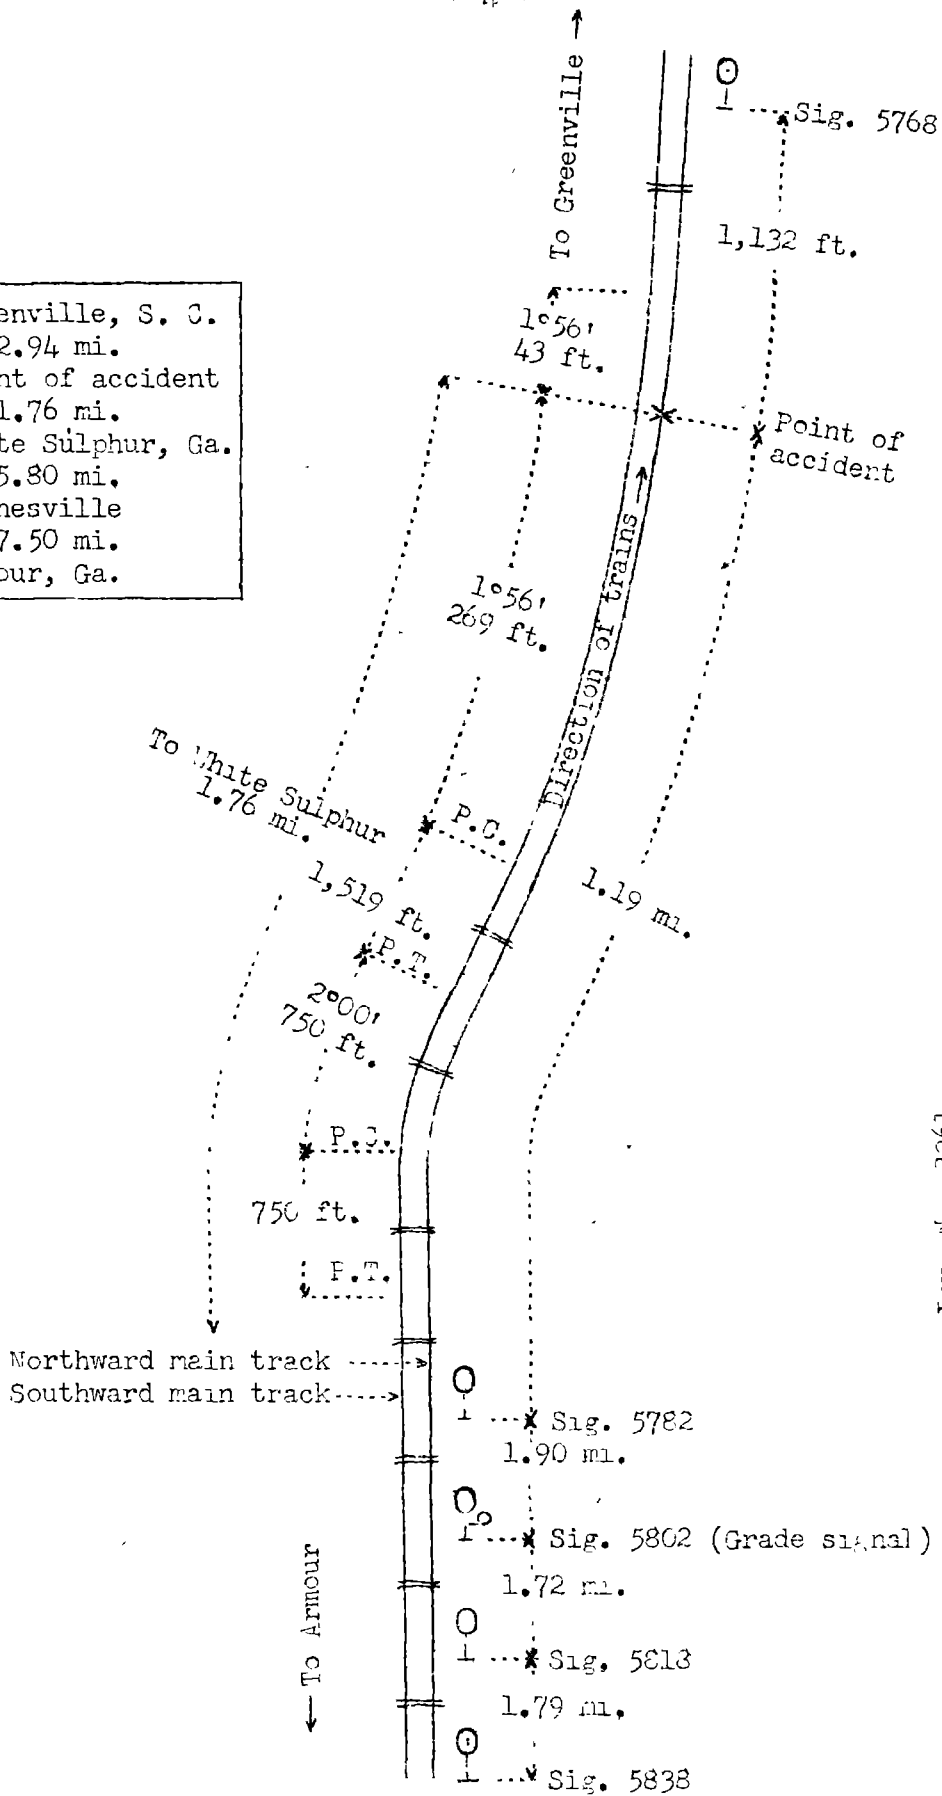
Inv. No. 2961
Southern Railway
White Sulphur, Ga.
December 19, 1945

- Greenville, S. C.
92.94 mi.
- X Point of accident
1.76 mi.
- White Sulphur, Ga.
5.80 mi.
- Gainesville
47.50 mi.
- Armour, Ga.
